Medora Corporation

Potable Tank Mixing & THM Removal

USCOPW-LOC1080.001

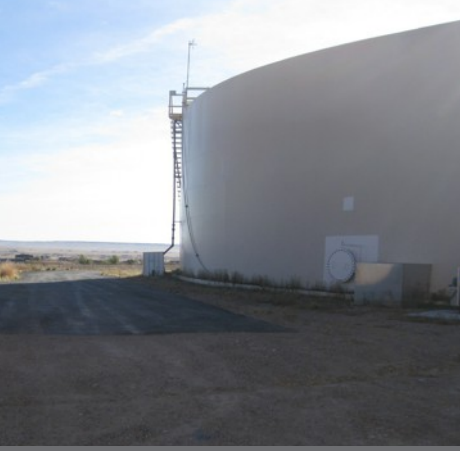
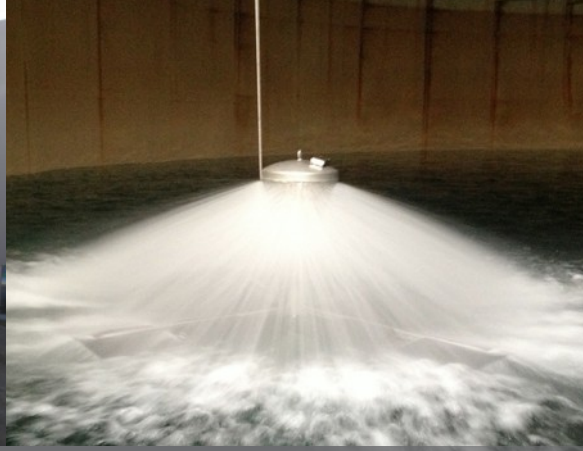
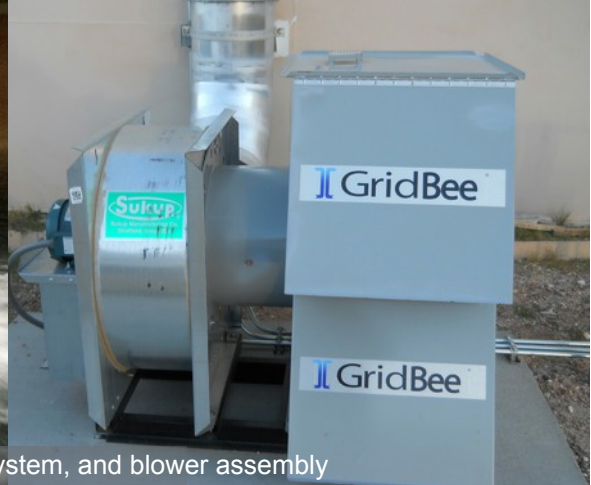
One of the three tanks, SN15 GridBee® Floating Spray Nozzle THM Removal System, and blower assembly

Solution: One (1) GridBee® SN15 Floating Spray Nozzle THM removal system with one (1) supplemental GridBee® GS-12 submersible mixer are installed in each of the three tanks. The GridBee® SN15 Floating Spray nozzle THM removal system is designed to achieve 40-50% reduction of THMs in this system. The Customer installed their first THM Removal system on July 15, 2013. They were so satisfied with it's performance that they purchased GridBee® THM Removal Systems for their two remaining tanks a little over a year later.

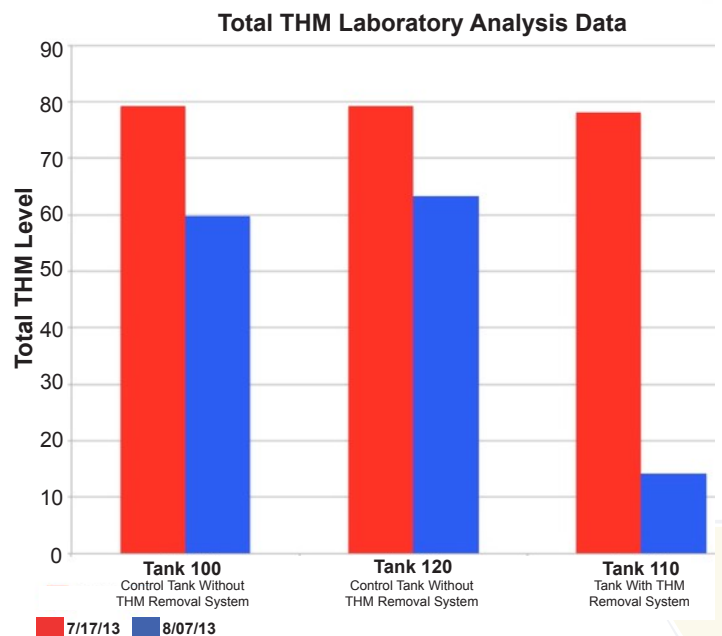
Results: In initial testing of the performance of the GridBee® SN15 Floating Spray Nozzle THM system and the GridBee® GS-12 that were first installed in tank 110, the District set up two control tanks that did not contain any THM removal equipment, tank 100 and tank 120. The graph (on the right) depicts the

outstanding results of this comparison study and shows approximately a 77 % reduction in THM levels in tank 110 that had the THM removal system. The readings depicted by the red and blue bars were taken about 3 weeks apart. Note that there was a natural decline in the THM levels in the control tanks during that period. The District was extremely happy with the results, and they installed the same GridBee® THM reduction systems for tanks 100 and 120 a little over a year later. The District will serve as a positive contact for future deployments
