Medora Corporation

Clearwell Mixing & THM Removal

USOHPW-LOC1027.001

Topics: potable, THM reduction, TTHM, stratification/water age, chlorine

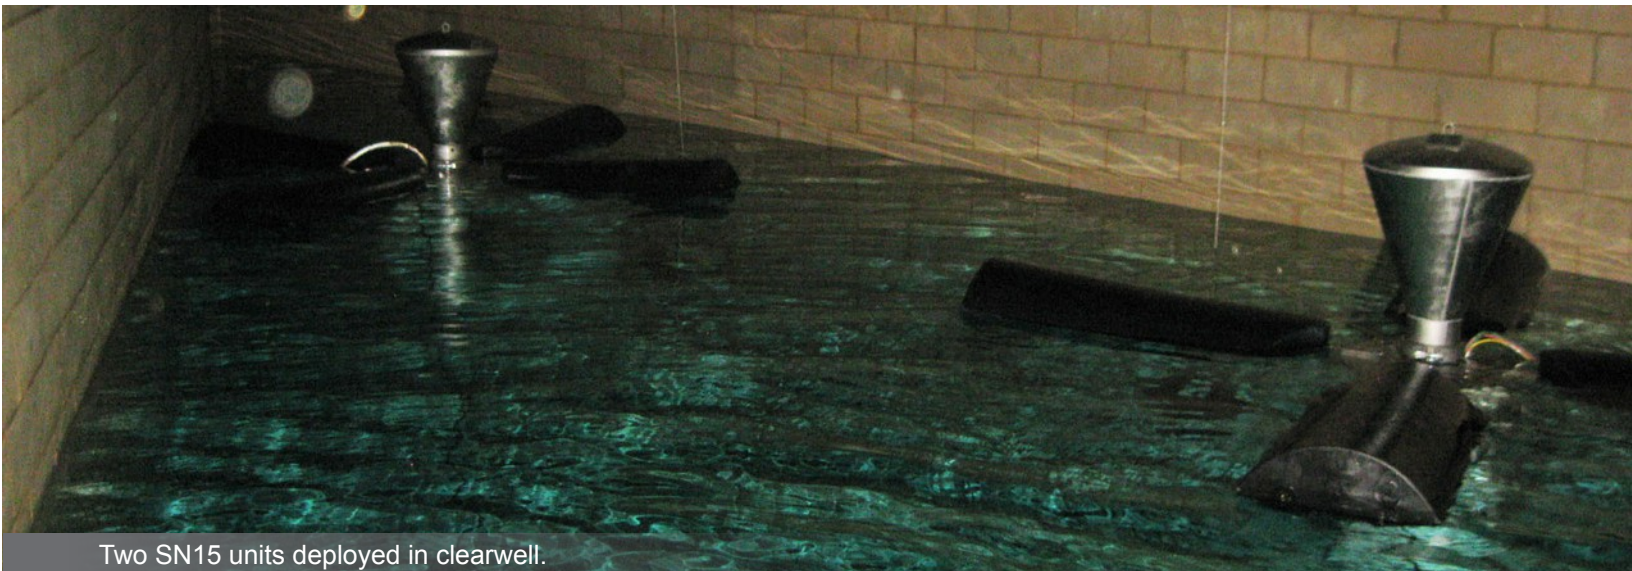
Two SN15 units deployed in clearwell.

Solution: One (1) GridBee® GS12 (mixer) unit was installed in Clearwell # 1 to increase TTHM production and reduce formation potential before the water entered Clearwell # 2. Two (2) GridBee® SN15 Floating Spray Nozzle THM Removal Systems were installed in Clearwell #2. This system was sized to accommodate the peak pumping rate of 2 MGD. Deployment Date: 3/13/2013
